# FIRE TEST REPORT

FP11420-001

**BUSH FIRE TEST ON WEEPA VENT 23-NGBW IN A  
BRICK VEENER WALL IN ACCORDANCE WITH  
AS 1530.8.1:2018**

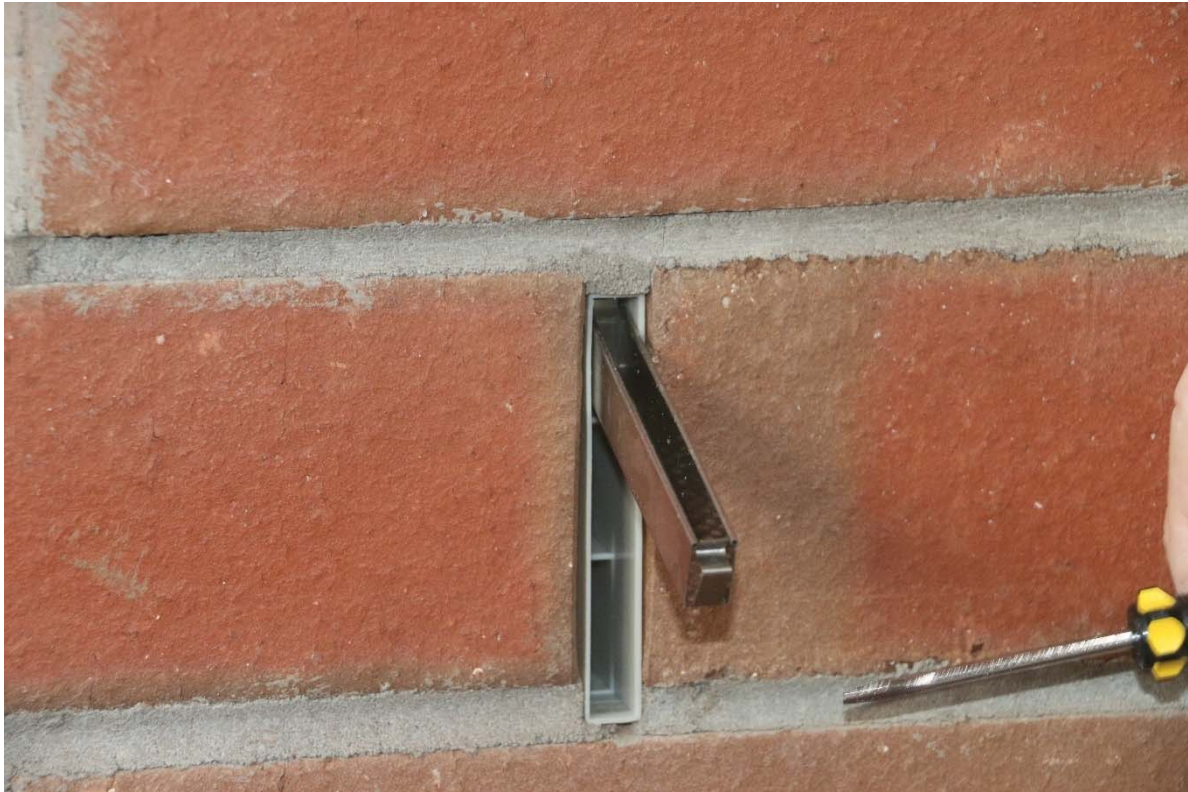
Photo 1: Test specimen exposed face prior to start of test with guard open

The test specimen consisted of a polypropylene body nominally 75 mm high x 10 mm wide x 105 mm long with a 316 grade stainless steel ember/vermin guard. The body included two horizontal internal stiffeners equally spaced at approximately 1/3 centres. The stainless steel guard had three rows of nominal 1.8 mm holes through the face of the guard and was designed to pivot within the body at the top.

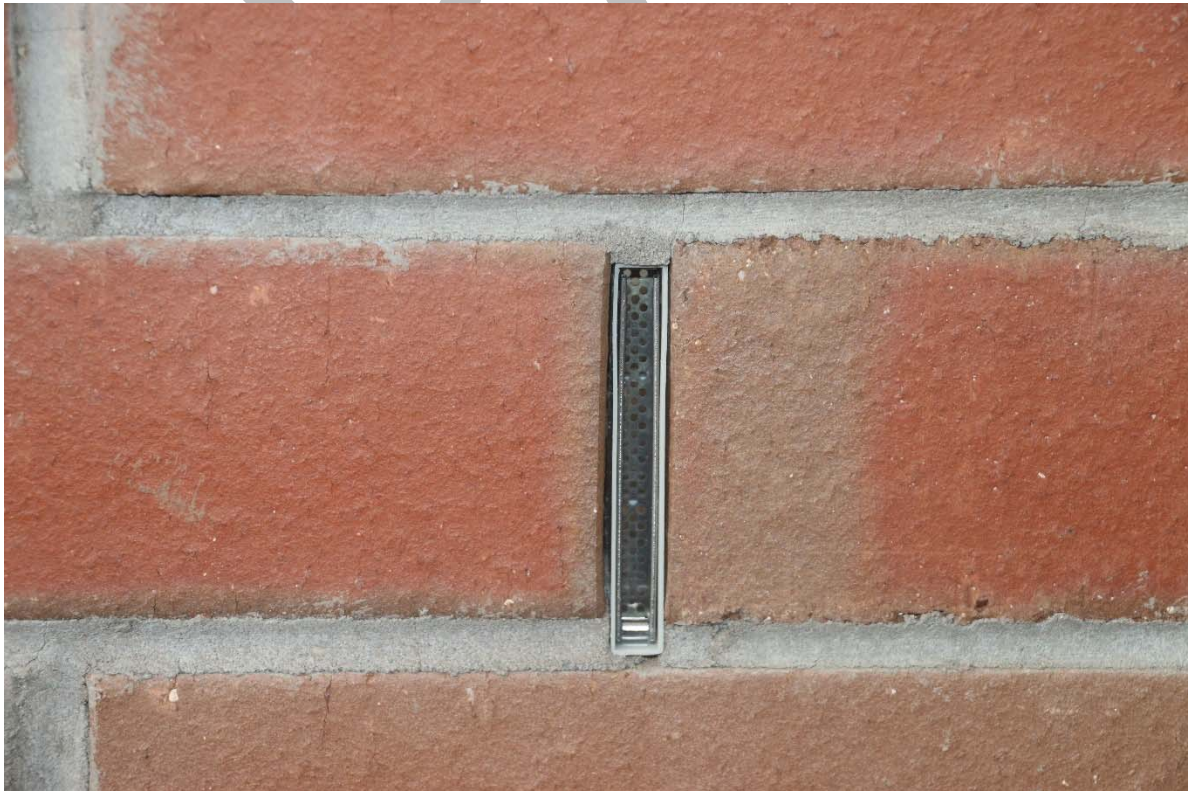
Photo 2: Test specimen exposed face before start of test

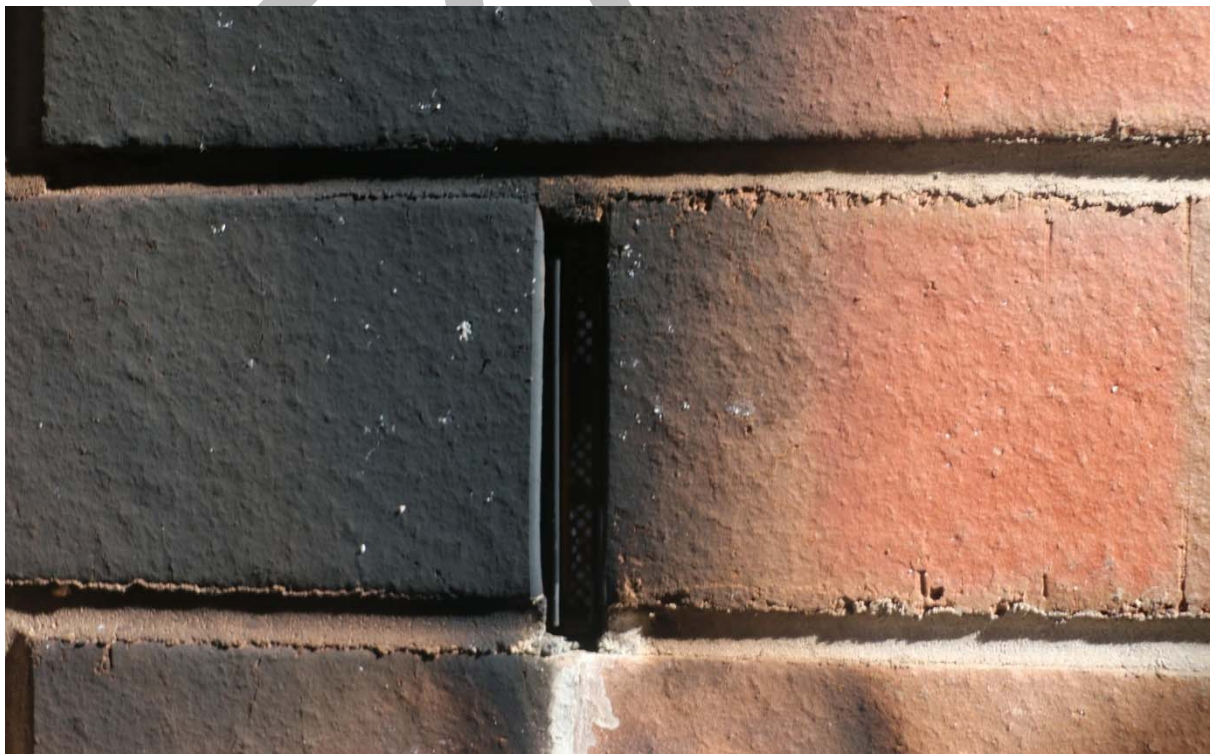
**Photo 4: Test specimen exposed face at the end of the test**

| Time (Min:Sec) | Test face | Observations |
|---|---|--|
| 10:00 to 60:00 | - | No significant observations. End of test |
